**NASA TECHNICAL
MEMORANDUM**

NASA TM X-3271 C.1

**EFFECT OF THERMAL CYCLING
IN A MACH 0.3 BURNER RIG
ON PROPERTIES AND STRUCTURE
OF DIRECTIONALLY SOLIDIFIED
 $\gamma/\gamma'-\delta$ EUTECTIC**

Hugh R. Gray and William A. Sanders

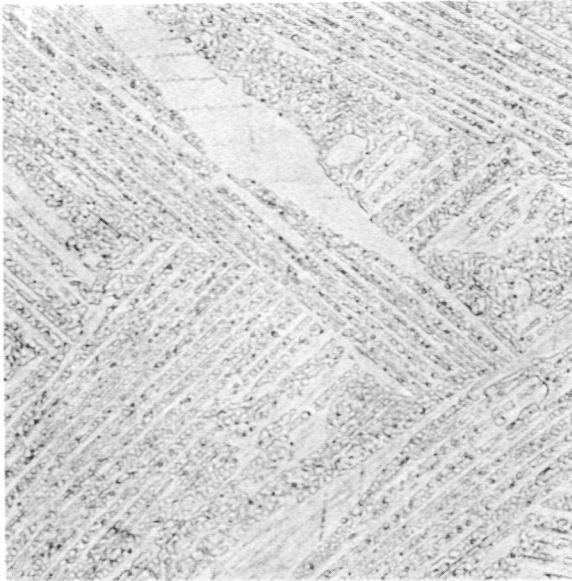
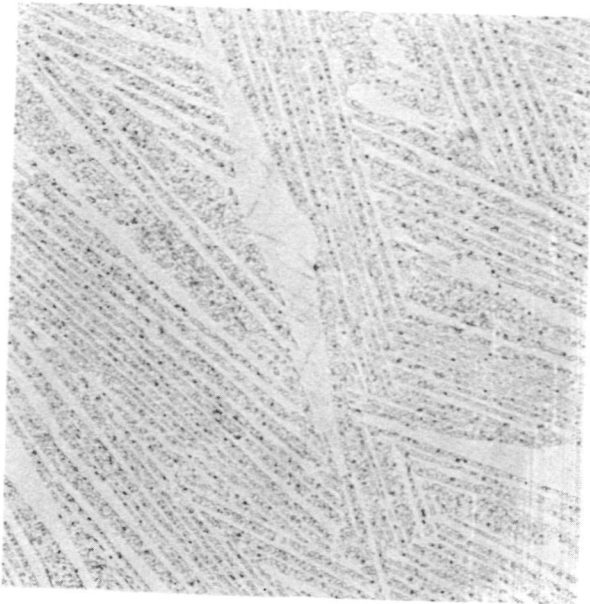
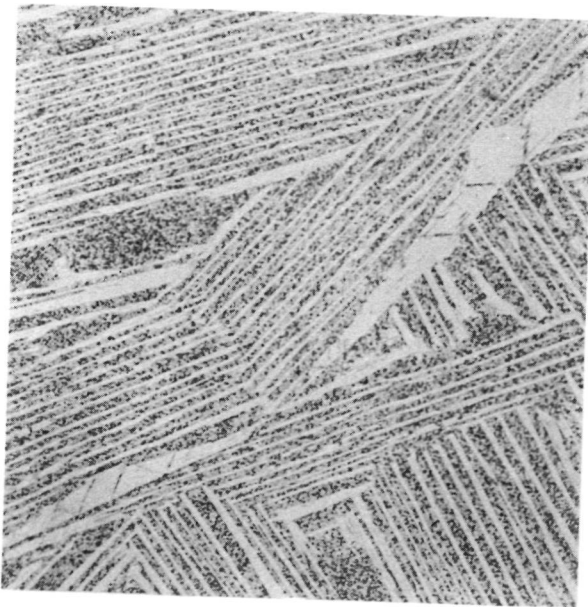
(a) Transverse - 1; bar temperature, $\approx 1070^{\circ}\text{C}$.

(b) Transverse - 2; bar temperature, 1090°C .

(c) Transverse - 3; bar temperature, 1100°C .

(d) Longitudinal - 2-3; bar temperature, 1090°C .

Figure 13. - Photomicrographs of thermally exposed bar A73-863-01 at positions 1 to 8 (fig. 12).

(e) Transverse - 4; bar temperature, 1100° C.

(f) Longitudinal - 3-4; bar temperature, 1100° C.

(g) Transverse - 5; bar temperature, 1080° C.

(h) Longitudinal - 4-5; bar temperature, 1080° C.

(i) Transverse - 6; bar temperature, 1000° C.

(j) Transverse - 7; bar temperature, 900° C.

(k) Transverse - 8; bar temperature, 500° C.

Maximum gamma prime coarsening was observed at locations 2 and 3 (approximately 1100° C), as shown in figures 13(b) to (d). Slightly less gamma prime coarsening was observed at locations 1, 4, and 5 (approximately 1070° to 1100° C), as shown in figure 13(a) and (e) to (h). Widmanstätten delta precipitation was observed in the gamma phase at locations 1 to 7 (900° to 1100° C), primarily in cellular regions (fig. 13(f)) but also in interlamellar regions. An unidentified precipitate, presumably gamma prime, was observed at locations 1 to 6 (1000° to 1100° C) within the delta phase (figs. 13(a) to (i)).
